UNIVERSITY OF MINNESOTA
ST. ANTHONY FALLS LABORATORY
Engineering, Environmental and Geophysical Fluid Dynamics

Project Report No. 575

*Monitoring an Iron-Enhanced Sand Filter Trench for
the Capture of Phosphate from Stormwater Runoff*

Final Report for the Project:
Assessing Iron Enhanced Filtration Trenches

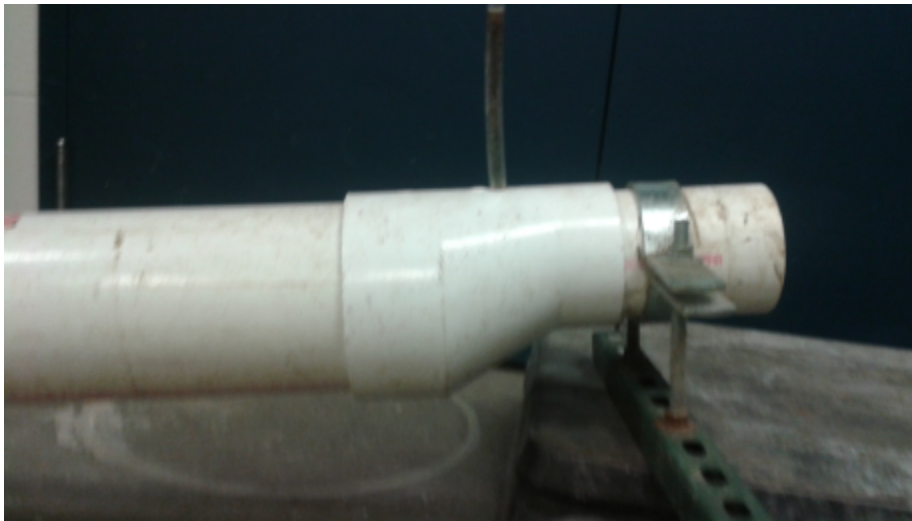
At the outlet of the drain tile extension, the pipe was expanded to a 6-inch diameter PVC pipe through an eccentric expansion fitting shown in Figure 5. The 6-inch diameter pipe was then extended approximately 33 inches and a thin metal compound weir plate was attached to the end of the PVC pipe. A schematic of the compound weir cross-section is shown in Figure 6.

Figure 5. Expansion from 4 to 6-inch diameter pipe.

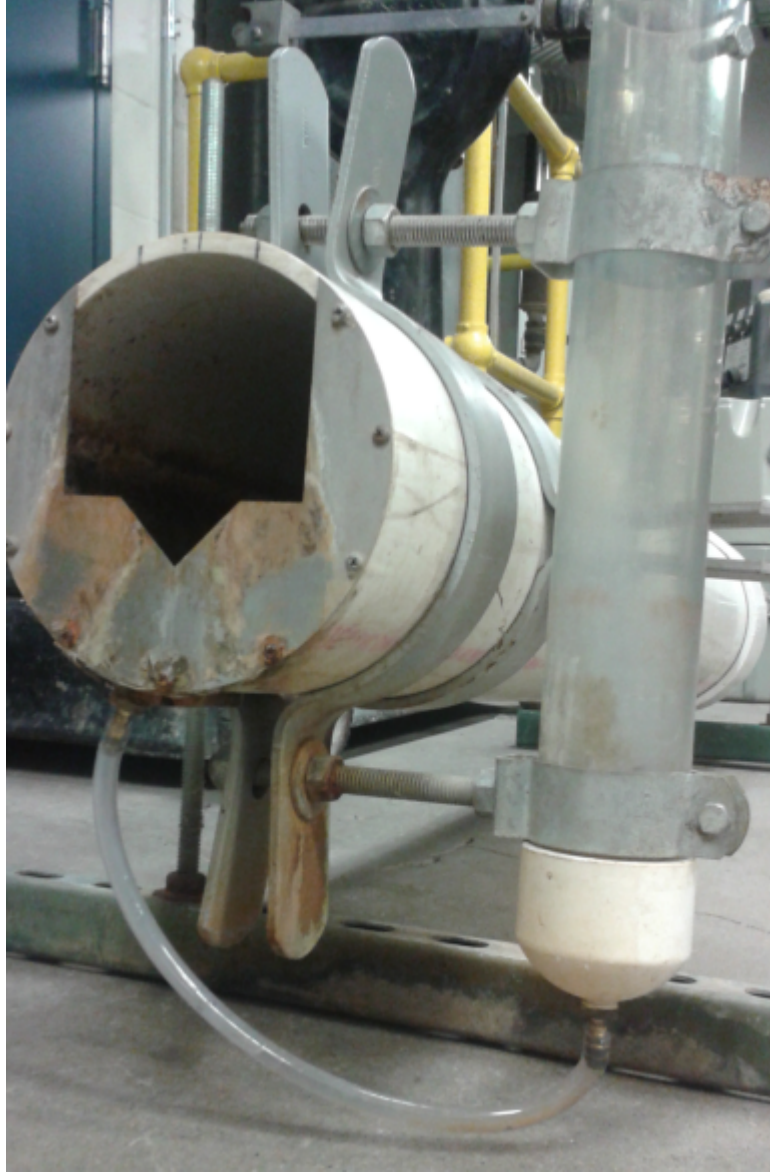
The head on the weir was measured using a Campbell Scientific CS-450 pressure transducer located in an adjacent vertical, ~2-inch diameter cylinder that was connected to the bottom of the 6-inch PVC pipe by means of one-quarter inch diameter flexible tubing (Figure 7). This arrangement allowed the water elevation in the vertical cylinder to match the water elevation in the 6-inch diameter discharge pipe, with the dampening of rapid fluctuations due to surface waves and turbulence, and a minimum of 3 inches of water above the transducer's sensor (necessary for improved accuracy).

Figure 7. Discharge end of 6-inch diameter pipe showing compound weir and vertical cylinder to contain a pressure transducer.

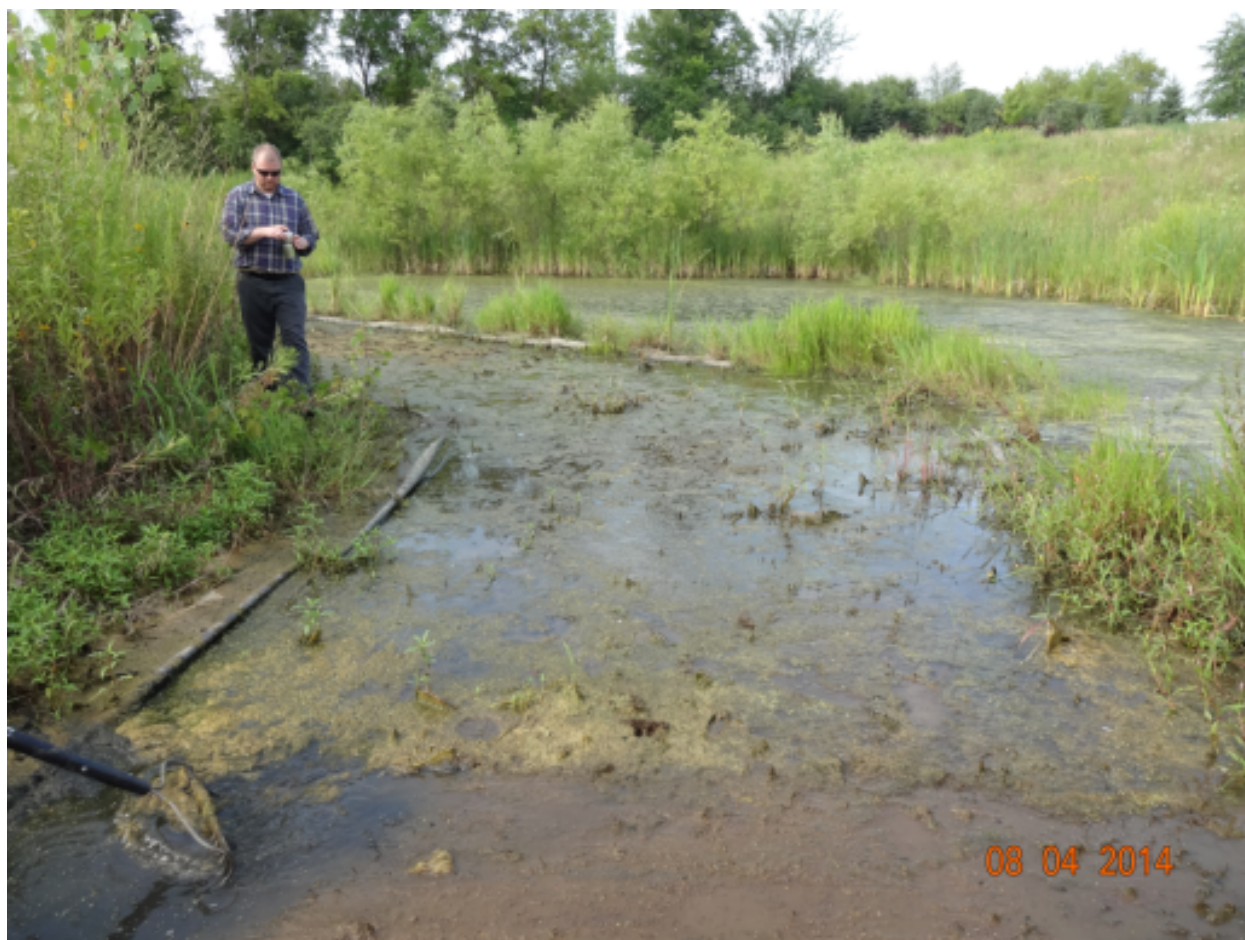
Figure 9. Submerged IESF trench in early August 2014.

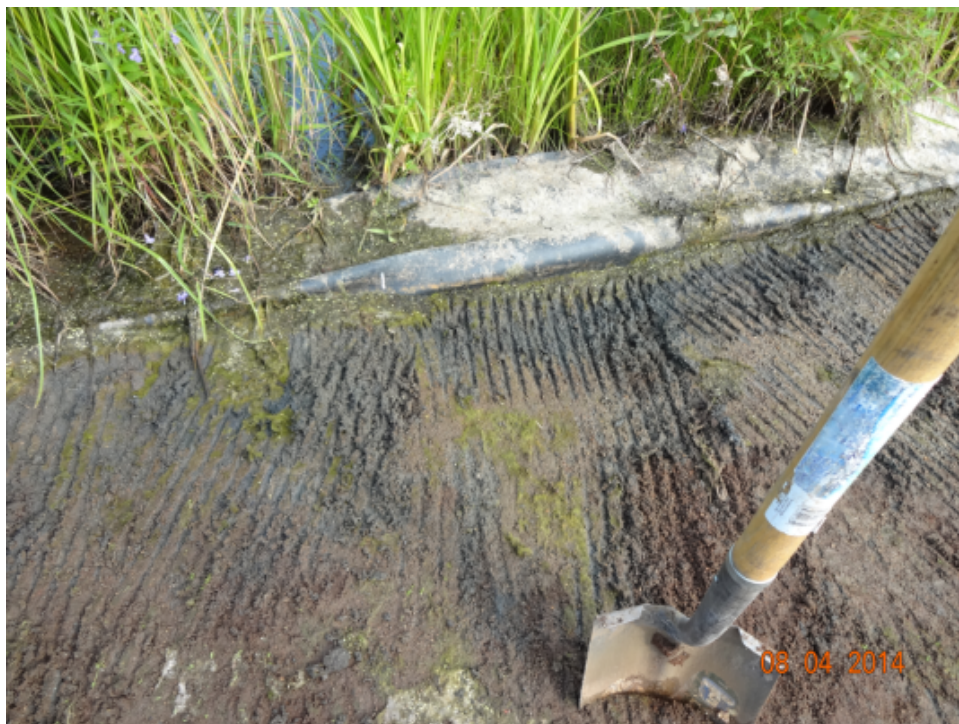
During Spring and early Summer of 2014, the filter began to filter water much more slowly such that it would remain submerged for days following a rainfall/runoff event. This is not desirable for at least two reasons: 1) water storage volume in the pond was unavailable for subsequent rainfall events, and 2) the filter must be able to dry as this prevents anaerobic conditions from developing and allows the iron to rust, the latter of which creates more phosphate adsorption sites. Visual inspection of the filter revealed solids had accumulated on or in the top portion of the filter media. These solids were in the form of duckweed and algae on the surface of the filter and a grey muck layer at or near the surface of the filter at some locations (Figure 15 and Figure 16). In some locations the grey muck was observed two to three inches below the surface.

Figure 15. Surface of the IESF trench showing accumulated grey muck.

One of the primary purposes of this non-routine maintenance was to remove a layer of grey muck (see Figure 15 and Figure 16) that was observed near and just below the surface of the filter. It is hypothesized that the grey muck was gleyed sand, which is iron-rich sand that has been reduced to ferrous iron due to anaerobic conditions from prolonged water saturation. Gleyed soils exhibit a similar appearance and texture as the grey muck that was observed at (and removed from) the site. The grey muck may have also contained decomposing organic matter may have developed as a result of prolonged water saturation caused by the intense precipitation conditions observed in June 2014 (previously discussed), the accumulation of fine organic material at or just under the surface of the filter from four previous rainy seasons, or both. It is

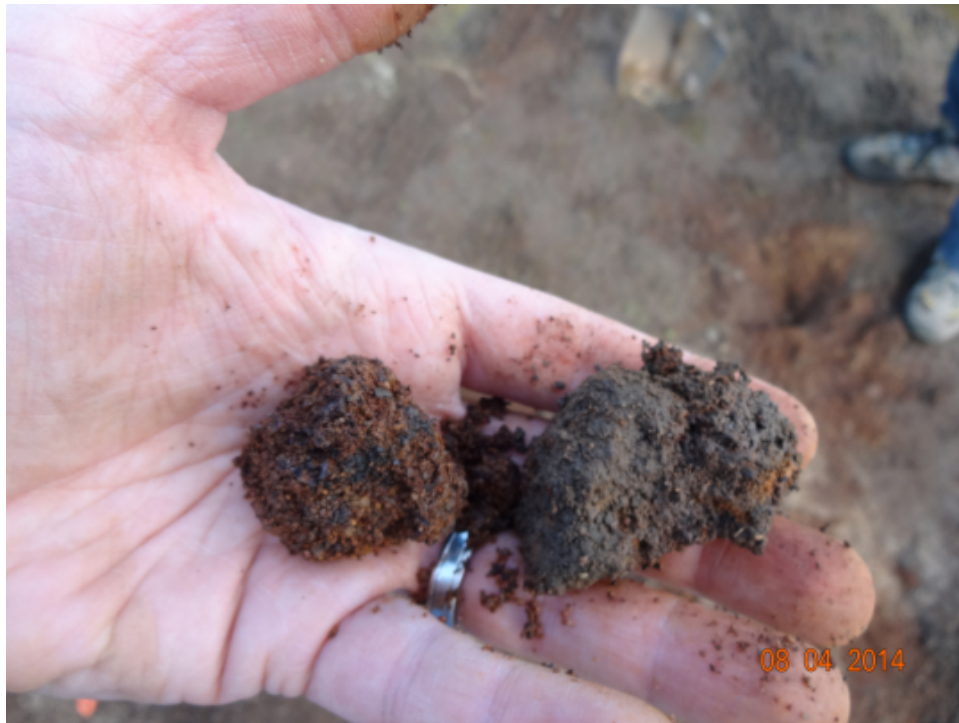
Figure 16. Sand-iron media taken from the filter (left) and grey muck (right).

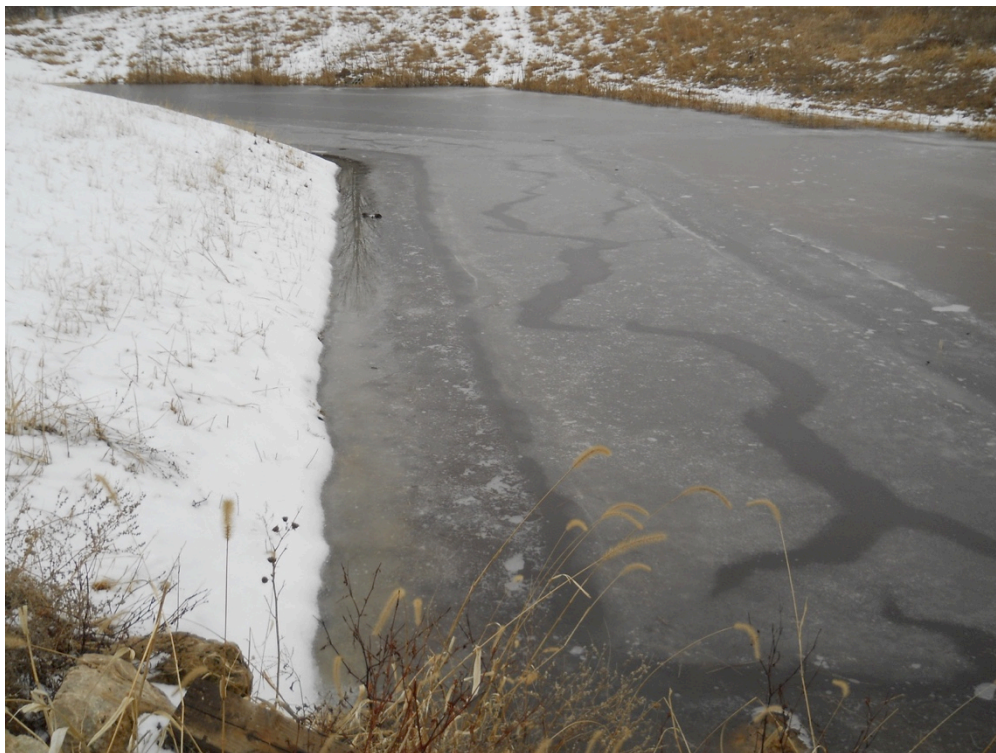
Figure 19: March 1, 2012 (looking South). Ice cover melting over IESF Trench. Approximately one year after construction.

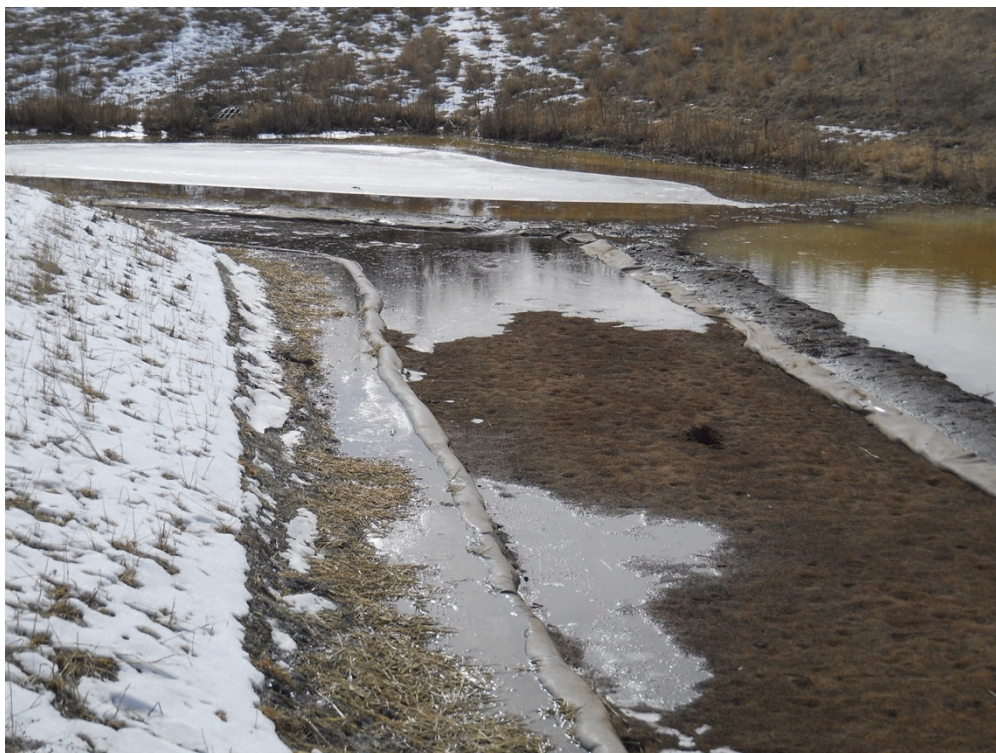
Figure 20: March 6, 2012 (looking South). IESF draining spring snowmelt.

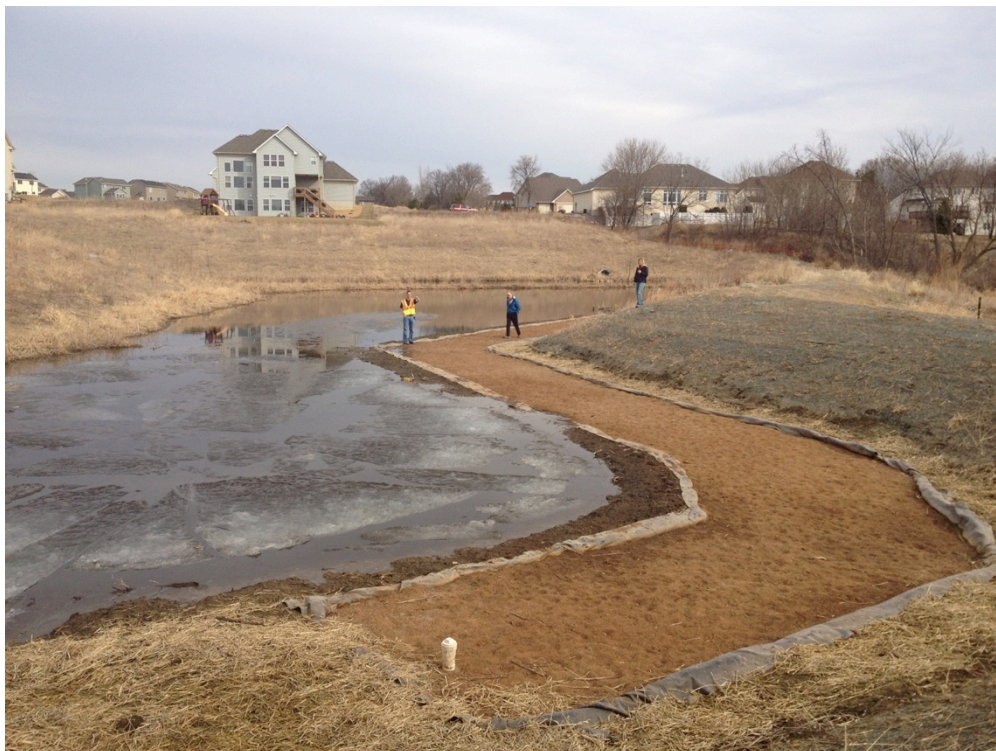
Figure 21: March 15, 2012 (looking North). IESF clear of ice and water level below filter surface.

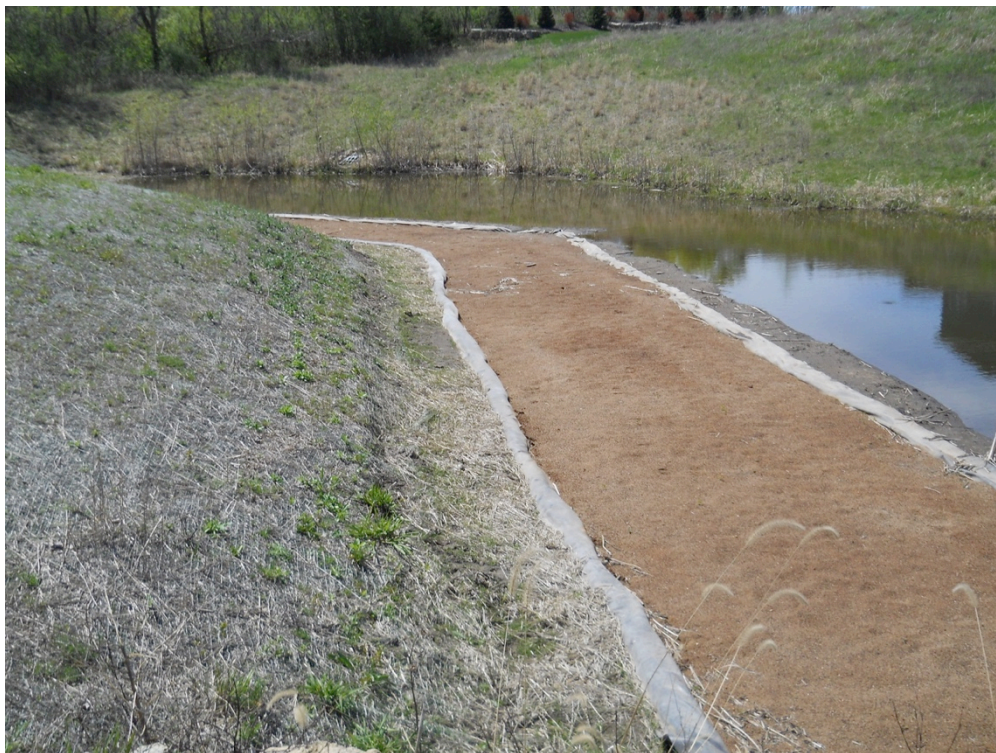
Figure 23: April 24, 2012 (looking South). IESF surface prior to rainfall event.

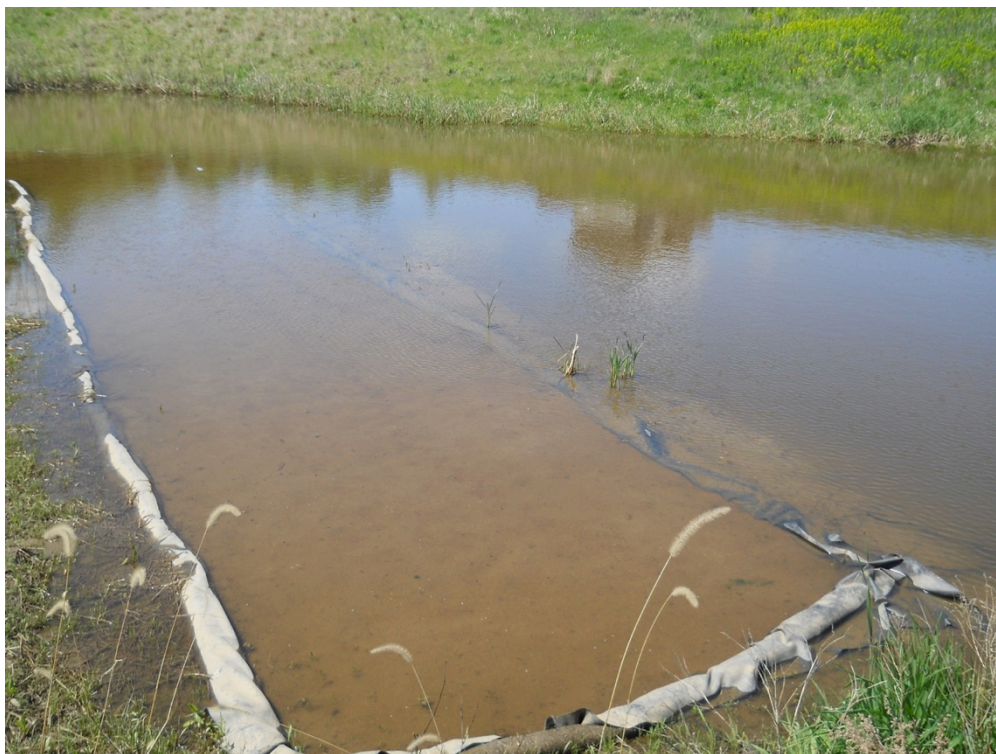
Figure 24: May 9, 2012 (looking South). IESF trench shortly after storm event. Water level above trench surface and passing through the IESF.

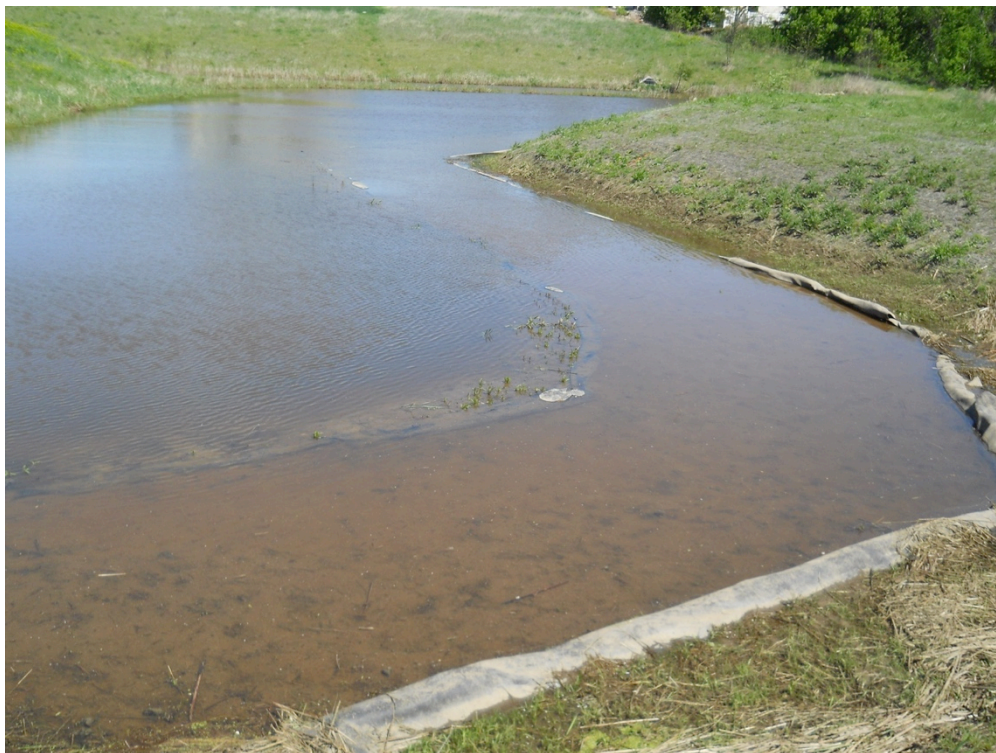
Figure 25: May 9, 2012 (Looking North). IESF trench shortly after storm event.

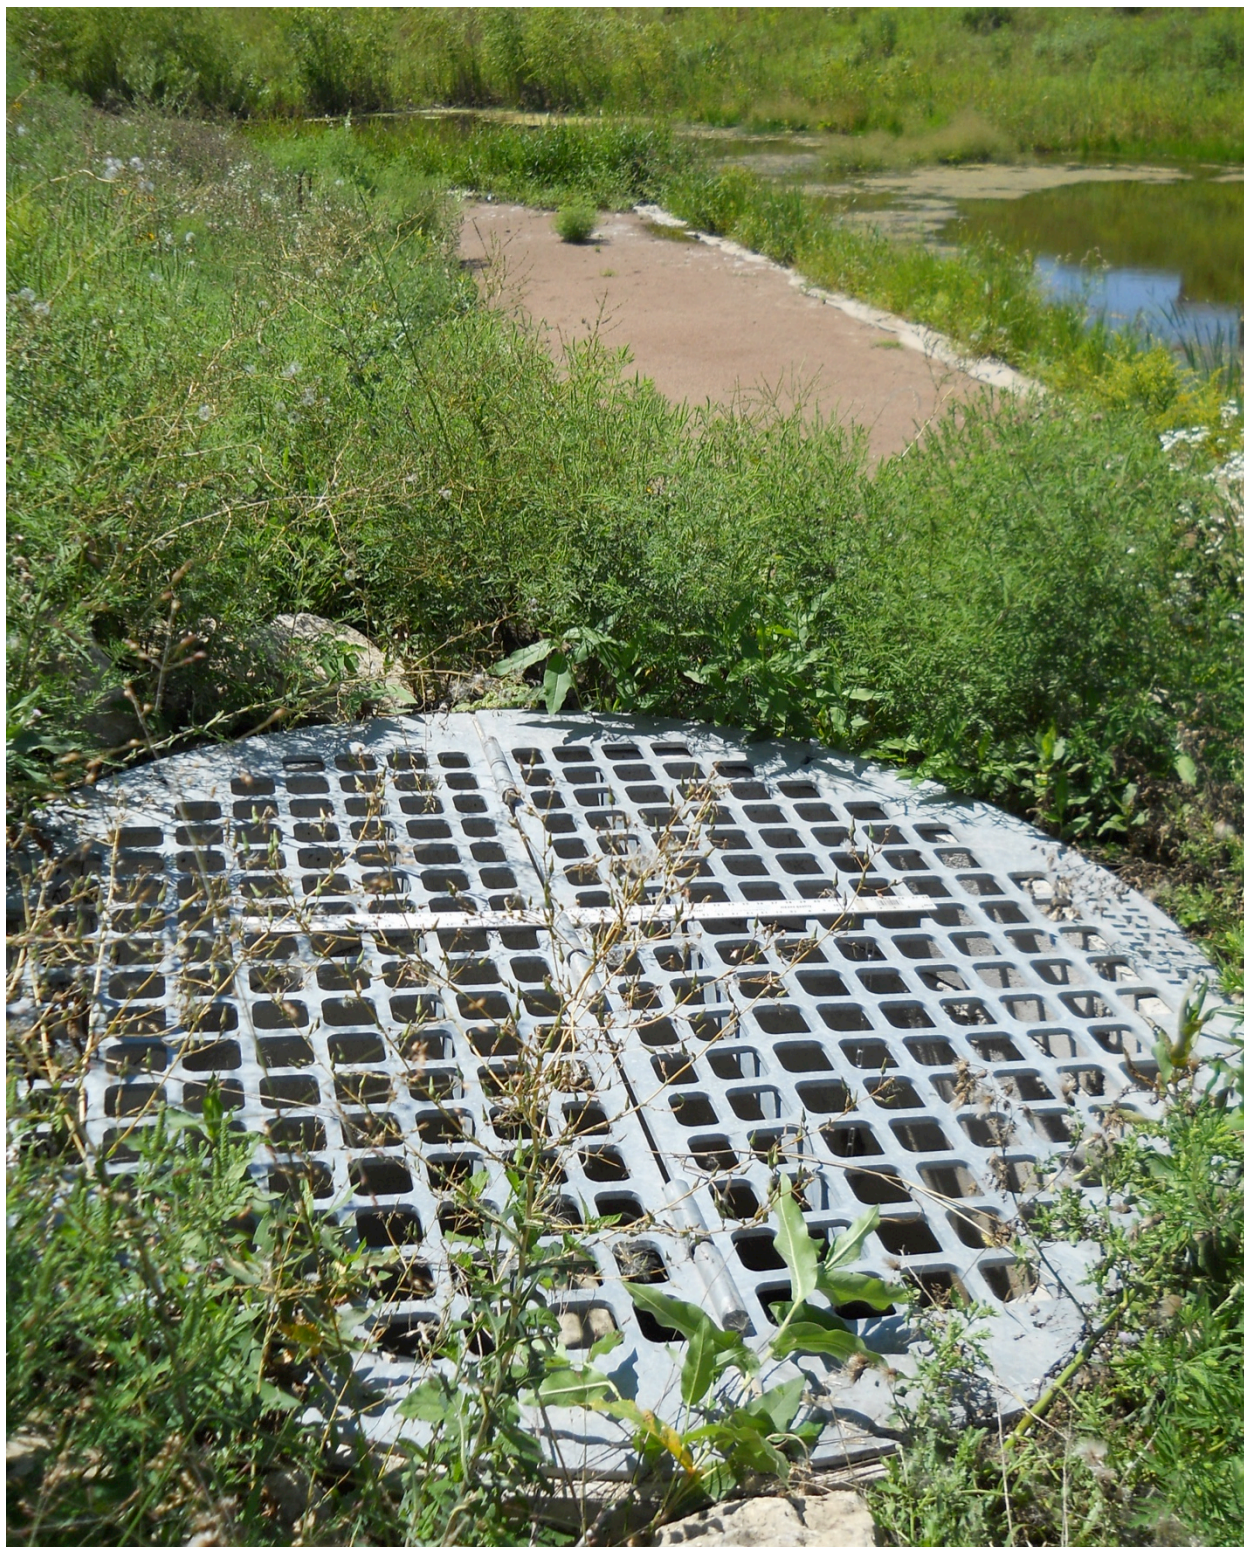
Figure 26: August 16, 2012 (looking south). Pond outlet control structure grate (foreground) and IESF Trench (background).

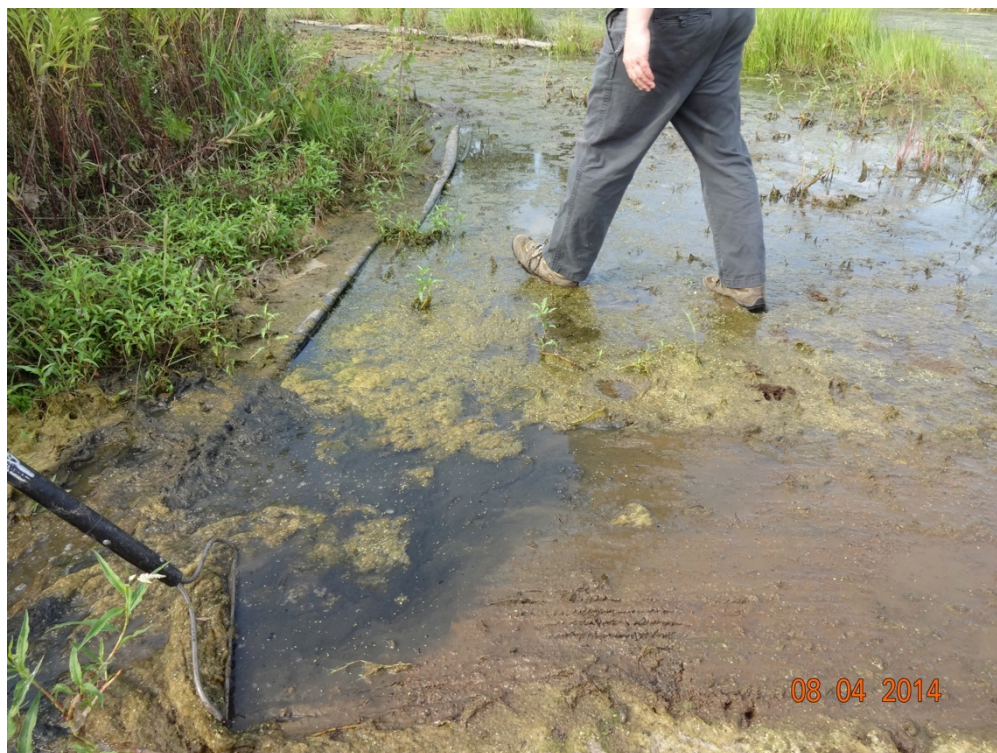
Figure 27: August 4, 2014 (looking South). Non-routine maintenance; raking algae and vegetation.

Routine maintenance was performed throughout this project and was scheduled based on visual inspection of the site. As recommended by Erickson et al. (2013), visual inspection should occur at least annually for every site and can be used to schedule routine, non-routine, and major maintenance. For this project, visual inspection and (a decrease in) hydraulic and phosphate removal performance were used to schedule non-routine maintenance for the site.

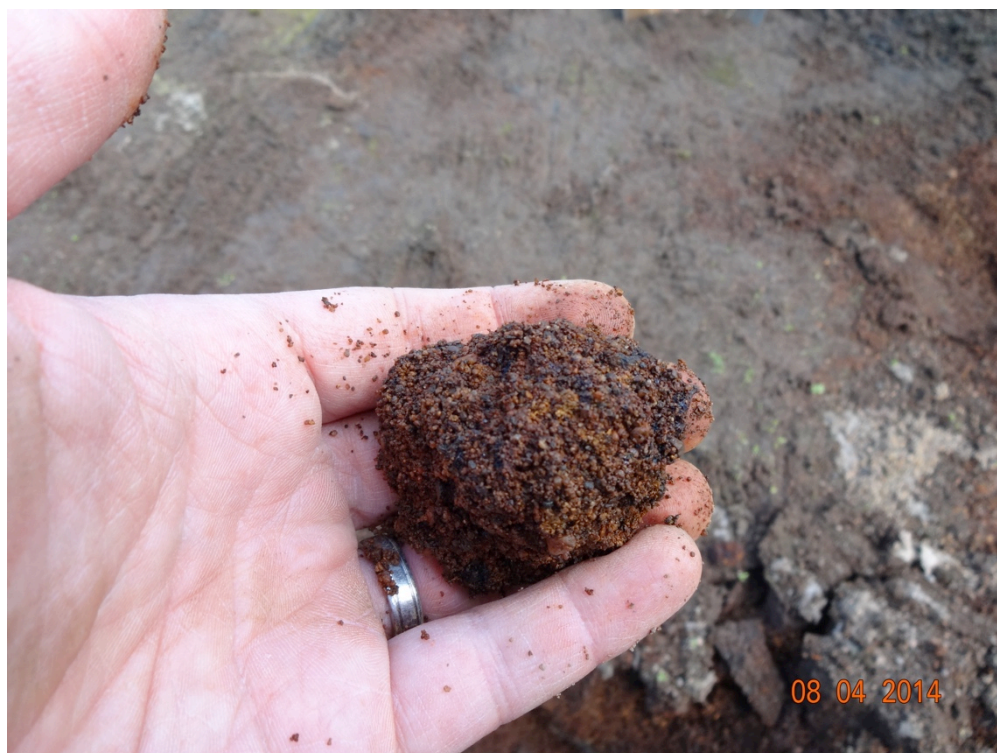
Figure 28: August 4, 2014. Non-routine maintenance; Iron Clumps found while raking.

5. If clumps of iron shavings develop, breaking up the clumps into small pieces (as small as practically possible) is recommended. Although these clumps do not reduce overall permeability, breaking up the clumps should allow the iron to become more dispersed in the sand and will increase the surface area available for phosphate adsorption (i.e., removal).

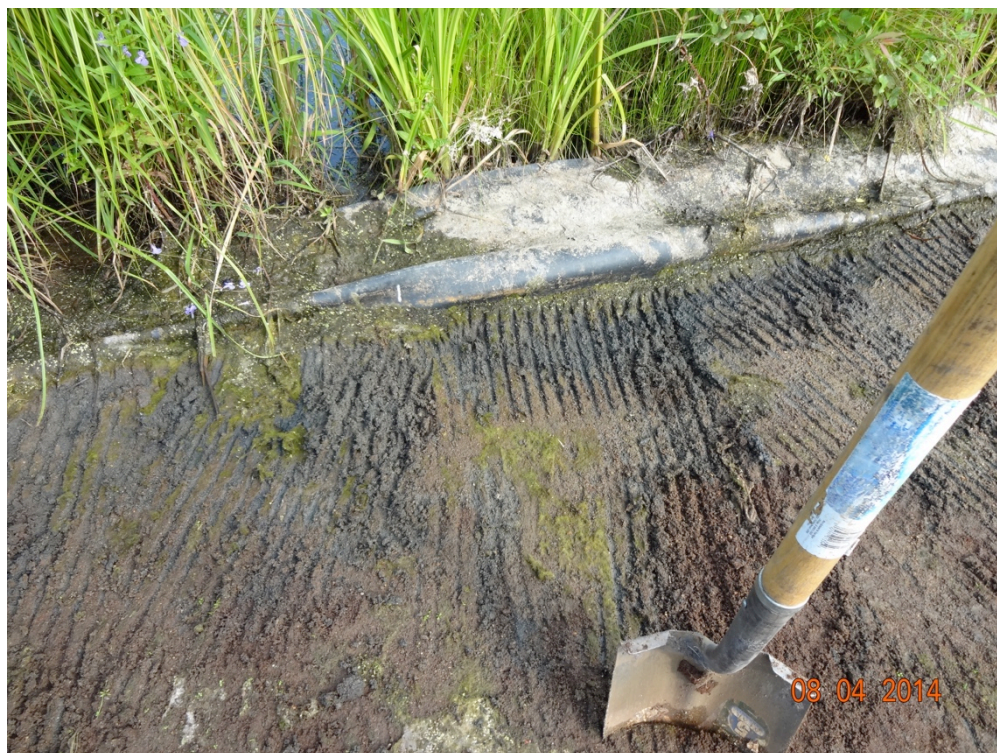
Figure 29: August 4, 2014. Non-routine maintenance; raking revealed grey muck layer that prevented flow through the IESF trench.

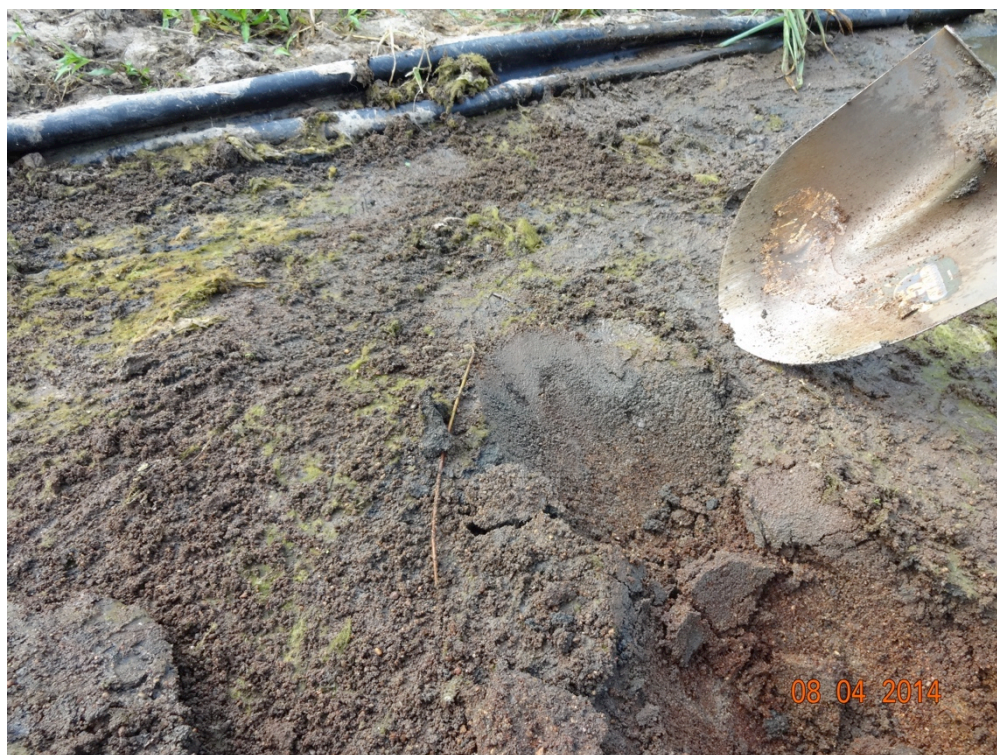
Figure 30: August 4, 2014. Non-Routine Maintenance. Grey muck layer near the surface.

Non-routine maintenance actions on other IESF trenches in the City of Prior Lake were often required to improve hydraulic performance. The non-routine maintenance performed on other trenches did not include removing grey muck (not observed at any other sites), but did include vigorous raking with a steel rake to break up iron-rich "crusts" that formed over the entire surface of the IESF trench. These crusts, often 0.5 – 1.5 inches thick, were impermeable and prevented the trench from filtering stormwater. Once broken, air bubbled through any standing water and hydraulic performance was restored. These other trenches, however, have not been assessed for phosphate retention so the impact of non-routine maintenance on this aspect of performance has not been evaluated. It is assumed, however, that IESF trenches that filter stormwater perform better than trenches that are sealed with an impermeable crust and do not treat any stormwater.

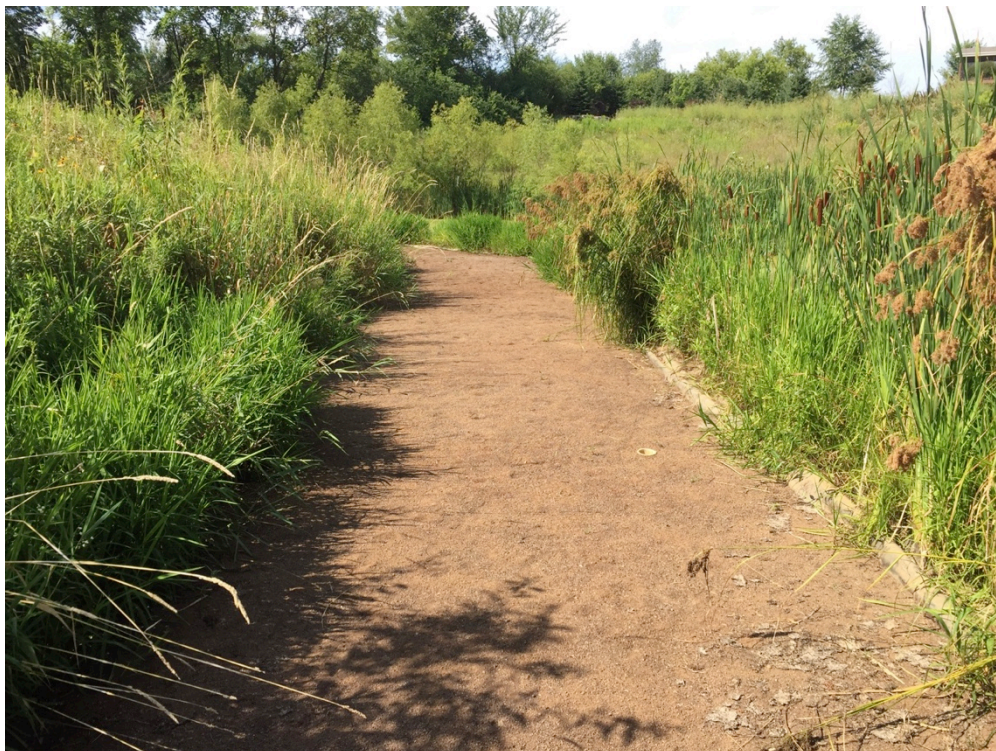
Figure 31: August 5, 2015 (looking South). View of the IESF at the end of the project.

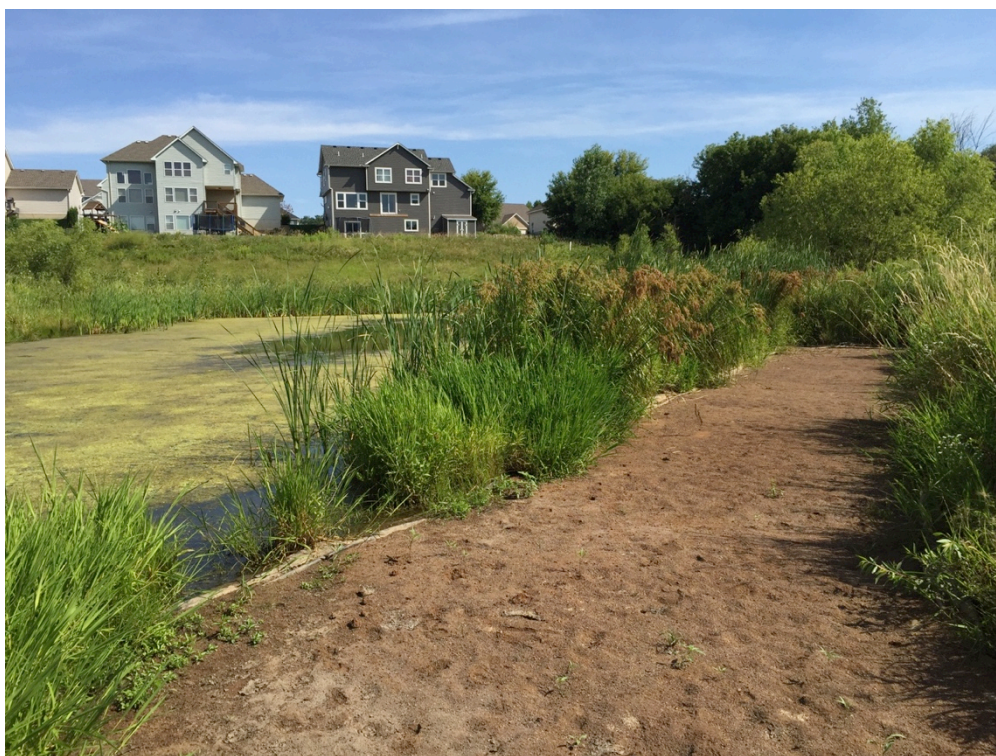
Figure 32: August 5, 2015 (looking North). View of IESF and low spot where stormwater first enters the trench during a storm event
